**RE: Preliminary Environmental Investigation at Central Middle School  
Greenwich, Connecticut  
MMI #5062-10-02**

## TEST PIT LOCATION MAP

CENTRAL MIDDLE SCHOOL ENVIRONMENTAL SOIL INVESTIGATION  
GREENWICH PUBLIC SCHOOLS  
9 INDIAN ROCK LANE  
GREENWICH, CONNECTICUT

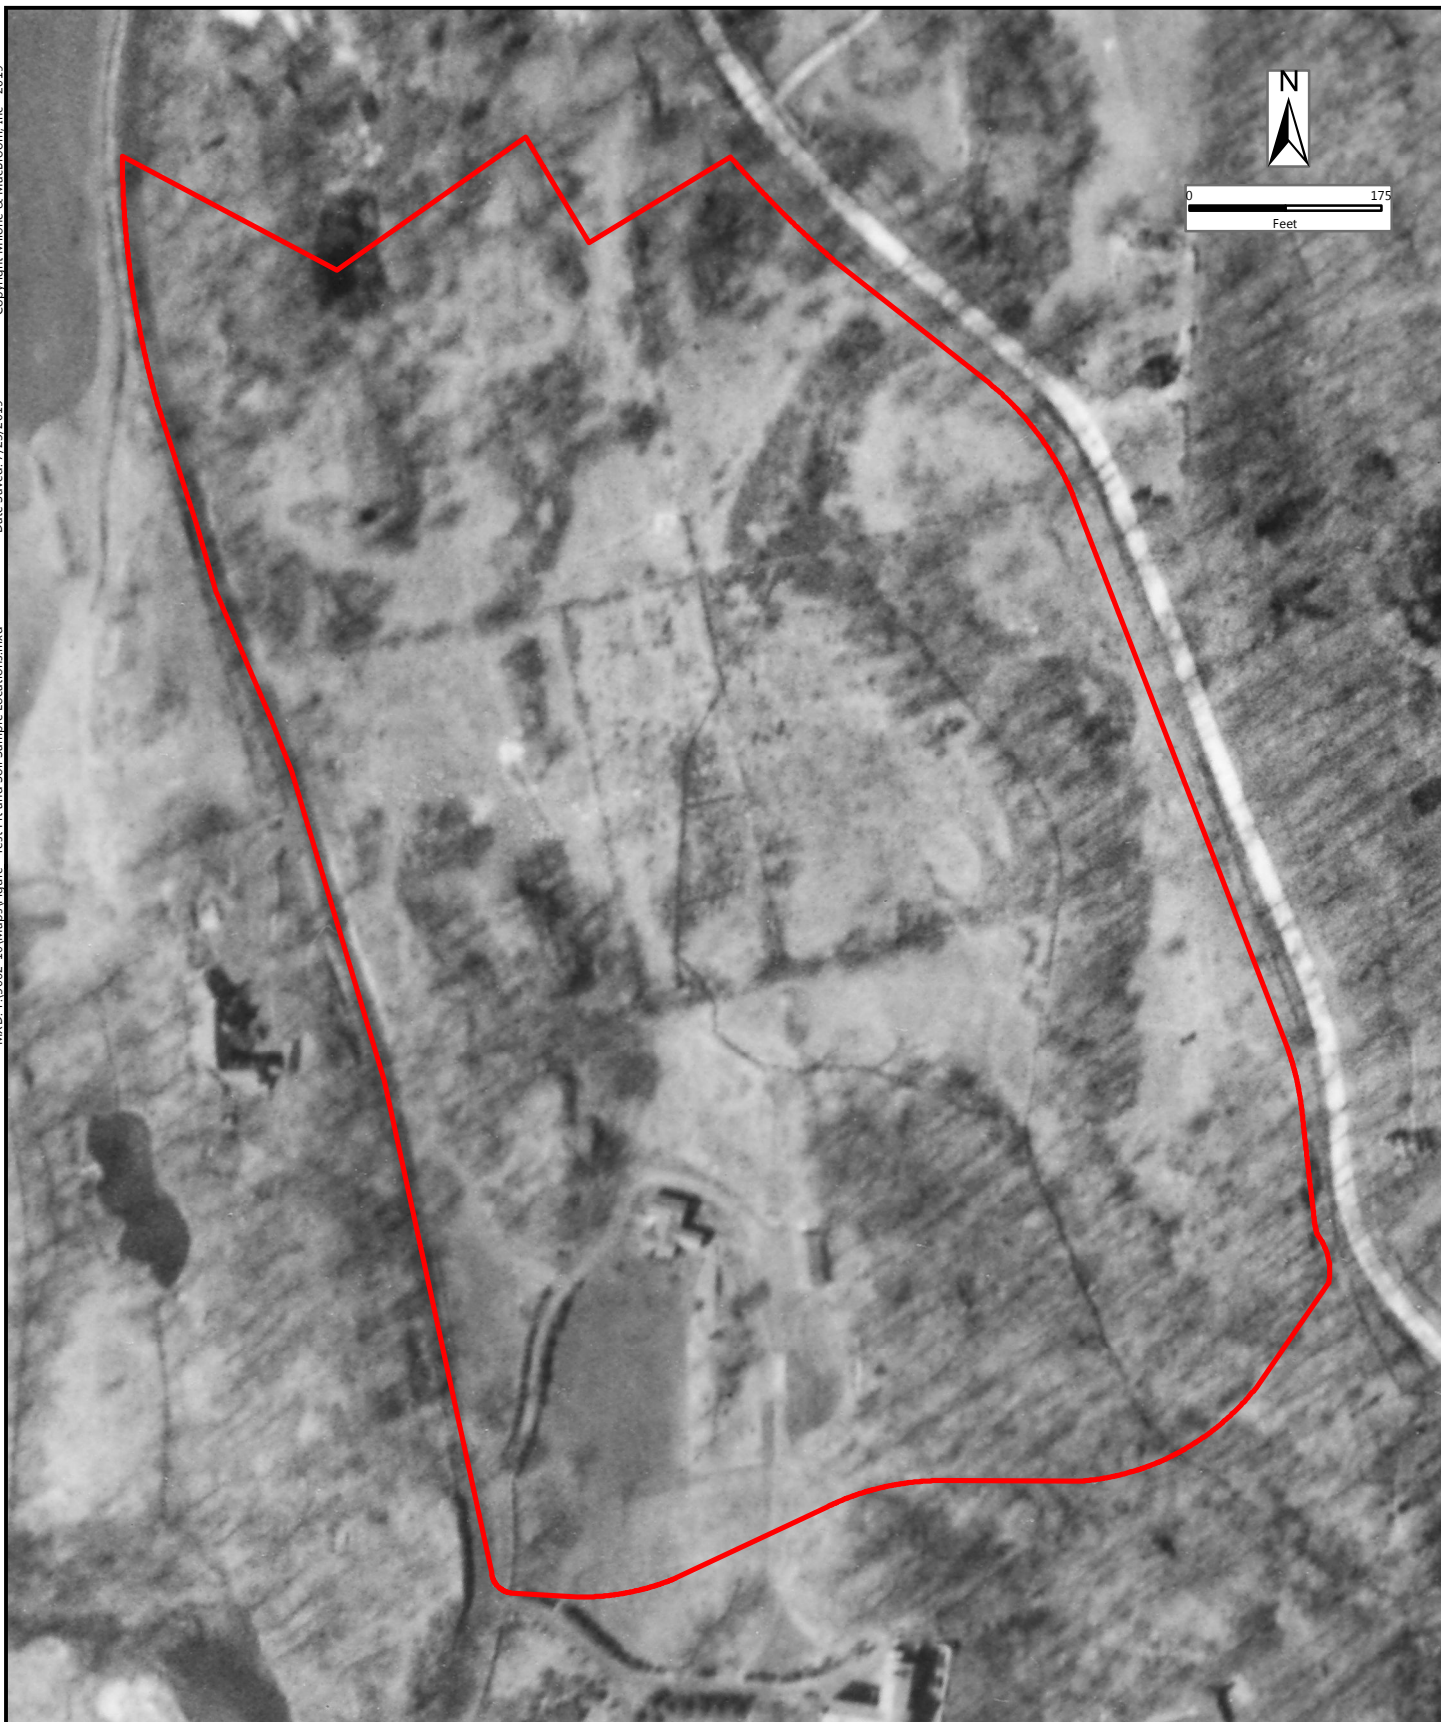
## 1934 AERIAL

Historical aerials from Connecticut Environmental Conditions Online (CT ECO) covering the following years were reviewed: 1934, 1951, 1970, 1985, 1990, 1996, 2004, 2008, 2012, and 2016. The aerial photography review indicated that the field may have been used for residential purposes with a few cleared areas in 1934. By 1951, the site appeared almost completely covered in woods and unused. In the 1970 aerial photo, the school building and playing field with one ballfield in the northern corner are apparent. The 1985, 1990, and 1996 aerial photographs show three ballfields on the athletic field, one each on the northern, western, and southeastern corners. By the 2004 aerial photo, only two ballfields remain, the ones in the northern and southeastern corners. In addition, the 2004 aerial photo also shows a structural addition to the northwestern side of the school building. The 2004 and forward photographs showed the field and the school building as it appears in the present.
