## GREENWICH HIGH SCHOOL ENVIRONMENTAL TESTING UPDATE

### Site Investigation Status

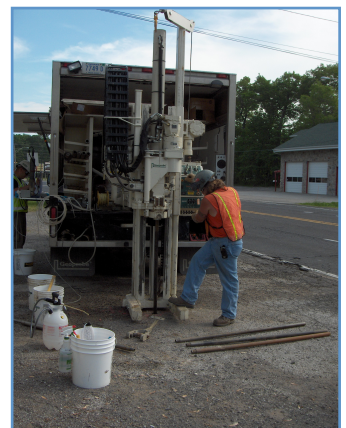
Soil samples were collected using a track-mounted drill rig

with a soil sampling device attached to it. At each sampling location, the sampling device was extended into the ground to collect soil samples to depths up to 20 feet. Each soil sample was reviewed by a geologist, who tracked the type of soil found (e.g., sand, clay, etc.), and the attributes of the sample (e.g., whether staining was noticeable, or the color of the sample, etc.). A total of 180 soil samples were collected from 49 borings.
